PRINCE WILLIAM COUNTY, VA  
DEPARTMENT OF PUBLIC WORKS

# Bull Run Watershed Study

Whitman, Requardt & Associates, LLP  
Engineers • Architects • Planners  
9030 Stony Point Parkway, Suite 220  
Richmond, Virginia 23235

March 2010

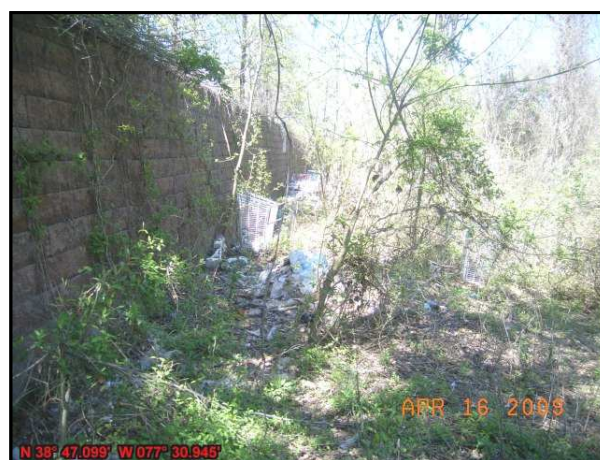
The Linden sub-watershed has three areas of moderate debris accumulation (L2-T1, L3-T2, and L7-T1). L3-T2 is an active dumpsite on commercial property (Costco Corporation). Access could be difficult due to a vertical retaining wall along the edge of the developed property. The Yorkshire subwatershed has one area with moderate trash accumulation. Site Y7-T1 is an inactive dump site for automotive debris and appliances. This area is within the riparian buffer of Reach Y7, making removal difficult.

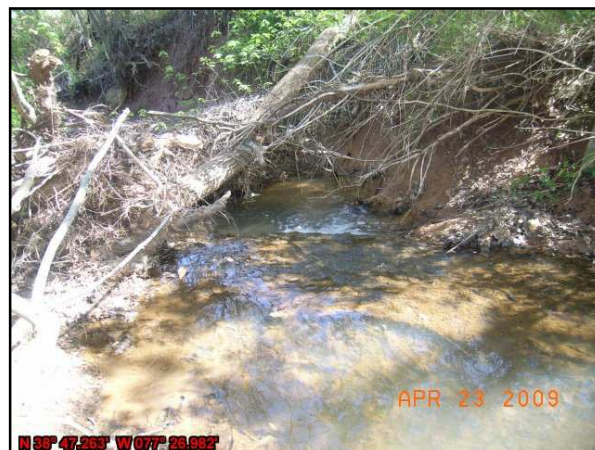
Only four exposed utility stream crossings were catalogued during stream field assessments (Table 15). The majority of the utility crossings appear to be well below the streambed. All of the assessed utility crossings are perpendicular to the stream channel. Only one utility crossing was considered moderately exposed and none were severely exposed. Two of the inventoried utility crossings were identified for stabilization or protection:

- Utility crossing Y3-U1 is an exposed concrete encased pipe which scored moderate due to bank erosion, pool scour, and restriction of upstream fish migration
- Utility crossing B6C-U2 is a stable crossing. However, downstream is a four to five foot head cut (B6C-H2) which is migrating upstream to the utility crossing

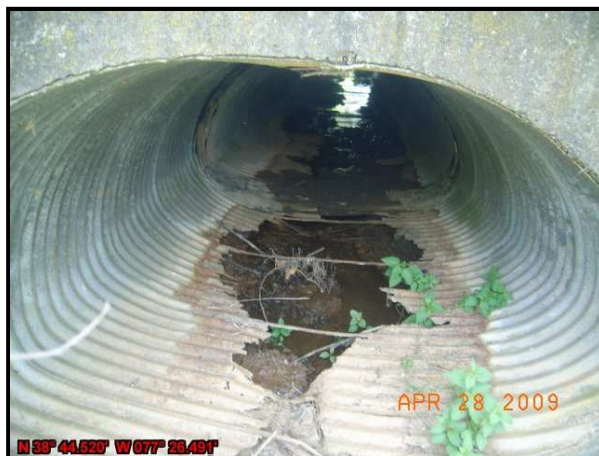
Three corrugated metal (B4-P1, B5-P1, and Y7-P1), and one plastic (L7-P2) culverts, are severely degraded and are in need of repair. In some cases the CMP has rusted completely through the bottom of the culvert allowing stream flow to pass under the culvert. Failure of the culvert can lead to failure of the roadway.

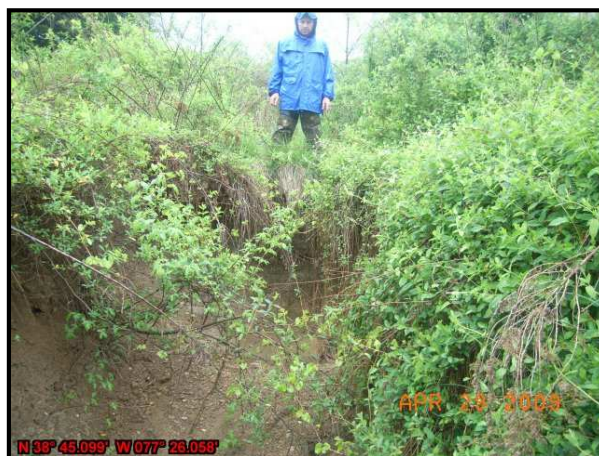
Head cuts (i.e., areas of vertical bed erosion), fish barriers, or obstructions that restrict stream discharge were evaluated and assigned a score of minor, moderate, or severe (Table 17). The instability of these areas has caused both the substrate and stream bank to erode. Six severe head cuts greater than two vertical feet were documented during our evaluation. They are as follows: B6B-H2, B6C-H2, L2-H1, L5-H4, L10-H2, and Y7-H2. Subwatershed Linden, the most developed watershed, contains the largest

number of severe head cuts. Most of these larger head cuts are in headwater streams. The most serious of the head cuts is B6C-H2 which is located immediately downstream of a utility crossing. This head cut is proposed for stabilization as part of a larger stream enhancement and stormwater facility retrofit.
